FINAL REPORT

STRUCTURAL RESPONSE TO SONIC BOOMS

FEBRUARY 1965

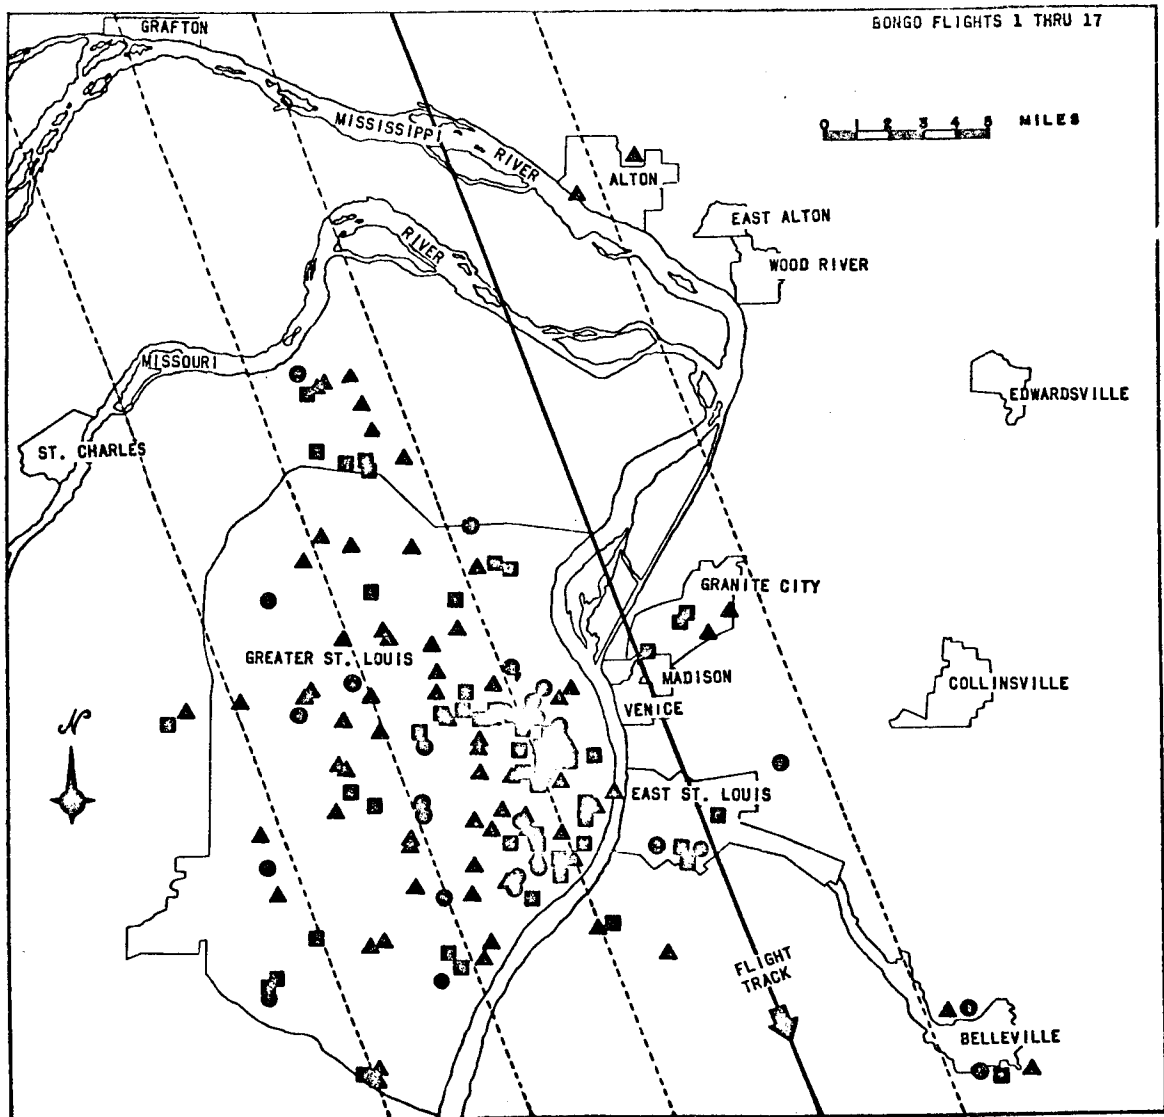
FIGURE NO. 20

The maximum overpressure occurs at a distance of 0 to 2 miles from the flight track and, theoretically, should cause the largest amount of damage. The overpressure will generally decrease with distance from the flight track and will generally increase with lower aircraft altitude. Refer to following table of Sonic Boom Overpressures prepared by National Aeronautics and Space Administration.

It is interesting to note that the larger and heavier B-58 flying at the same altitude and at a lesser supersonic speed than the F-106, caused a greater overpressure from 0 to 10 miles from the flight track, and an overpressure approximately equal from 10 to 16 miles from the flight track.

The maps of the individual flights indicate that more damage investigations were made for the B-58, flying at 35,000 feet, than for any of the other flights.

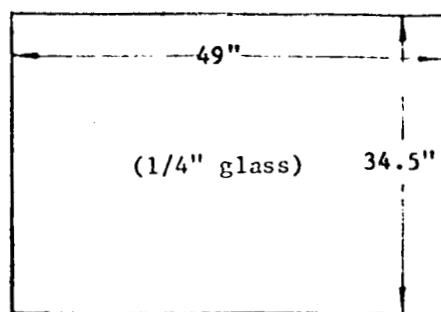
Figure 2. Window Dimensions

The natural frequencies of both windows were measured by striking the window and then recording the resulting vibration. The natural periods and frequencies of vibration are as follows:

<u>Window</u>	<u>Period</u>	<u>Natural Frequency</u>
1414 (Small crack)	.05 Sec.	20 cps
1415	.05 Sec.	20 cps

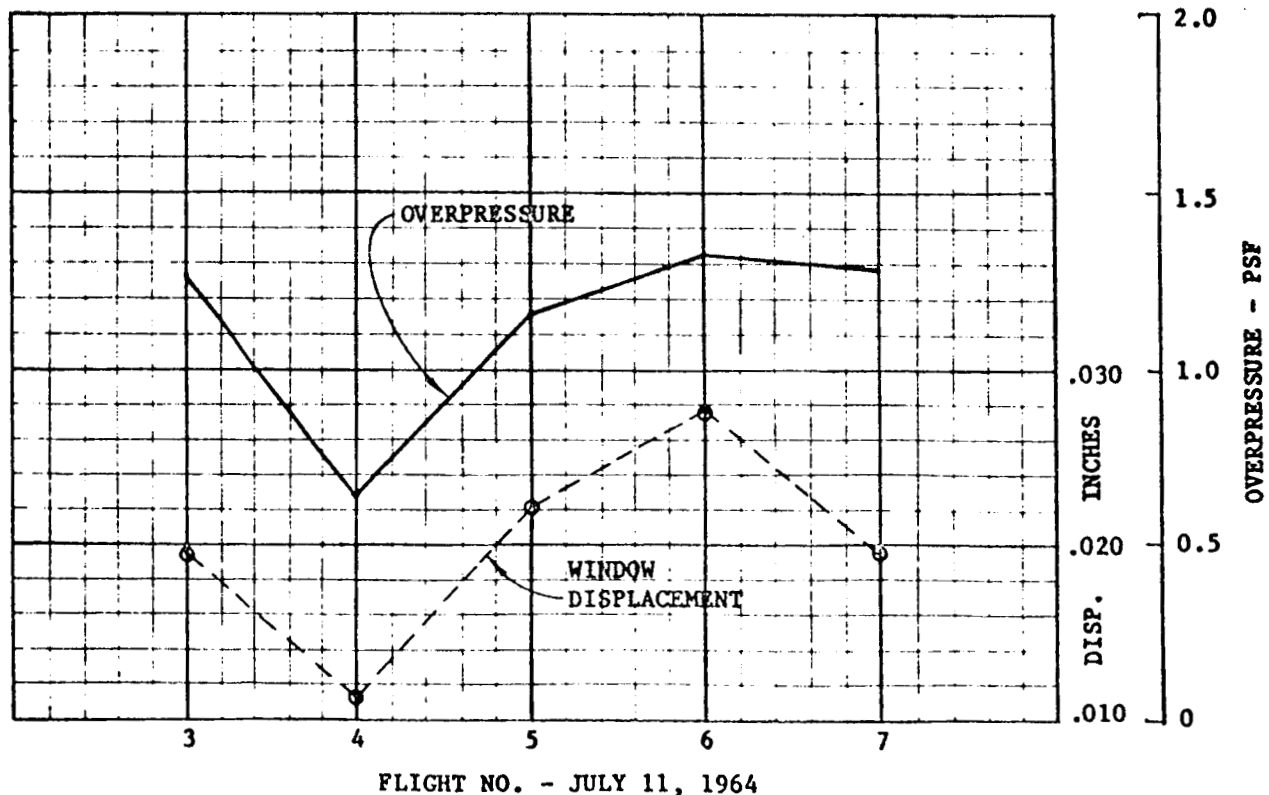
Figure 3. Window #1415 Displacement vs Overpressure

It may be of interest to note that the window deflections produced by rapping on the pane for the purposes of determining natural frequency in most cases equalled or exceeded the deflection produced by the overpressures occurring during the test. Note that the deflection produced by rapping on window #1415 (page 18) amounts to 12 millimeters while the deflection produced from the 1.33 PSF overpressure (Flight 6 - page 20) amounted to 10 millimeters for same instrument settings.

Under certain conditions, greater window glass displacements than those recorded could possibly occur. If the time duration of the boom is equal to an integer multiple of the natural period of the window structure, a displacement amplification could result. Thus, under unusual conditions, the amplitudes could be roughly double those recorded here. In the case of window #1415, if the boom duration (N wave total length) was exactly .05 (probably impossible), .10, .15, .20, or .25 seconds, greater deflections could occur. (Note: Also, the direction of maximum deflection, i.e. in or out, could vary.)
